Montes Bajo, M., Hodges, C., Uren, M. J., & Kuball, M. (2012). On the link between electroluminescence, gate current leakage, and surface defects in AlGaIn/GaN high electron mobility transistors upon off-state stress. *Applied Physics Letters*, 101(3), [033508].  
<https://doi.org/10.1063/1.4737904>

# **On the link between electroluminescence, gate current leakage and surface defects in AlGaIn/GaN high electron mobility transistors upon off-state stress**

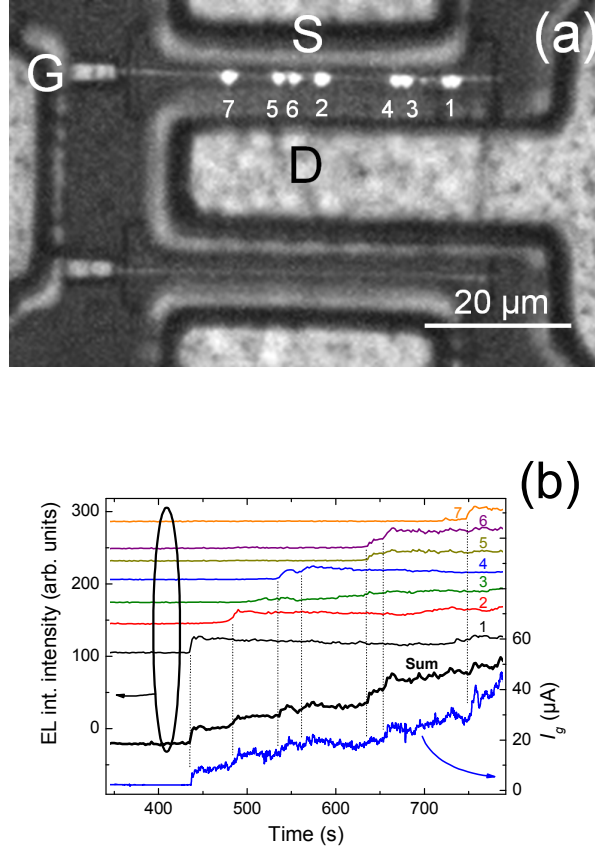
Figure 1. (a) Electroluminescence (EL) image from a representative 50  $\mu\text{m}$ -wide device stressed at  $V_{gs} = -15$  V and  $V_{ds} = 30$  V for 760 seconds, where only the upper finger is biased. The EL image is overlaid on a white light image of the device. The numbers indicate the order of appearance of the EL spots. (b) EL integrated intensity as a function of stress time from each of the EL spots of (a) as indicated. The sum of the EL integrated intensities of all the seven spots is also shown. Curves are offset for clarity. The figure also shows  $I_g$  as a function of stress time. Vertical dotted lines are a guide to the eye.

Figure 1(a) shows an EL image from a representative 50  $\mu\text{m}$ -wide device after 760 s at  $V_{ds} = 30$  V and  $V_{gs} = -15$  V. The EL image is overlaid on a picture of the device taken under white light illumination. A set of EL spots can be seen along the

drain edge of the gate, associated with the higher electric field in that region. This phenomenon was consistently observed in all the devices tested, and, in general, the longer the accumulated stressing time, the higher the number of EL spots that could be seen on the EL pictures and also the higher the value of  $I_g$ , all in agreement with previous reports<sup>3, 5, 8, 10, 11</sup>.

Figure 1(b) shows  $I_g$  as a function of stress time for the device of Figure 1(a).  $I_g$  becomes noisier and increases abruptly at the same time the first EL spot appears on the EL images. Then,  $I_g$  keeps increasing with time in a step-like manner. Figure 1(b) also shows the integrated EL intensity from each of the first seven EL spots to appear on the device (offset for clarity). There is a very good correlation between the appearance of each new EL spot and each of the steps in the increase of  $I_g$ , indicating the generation of defects underlying each EL spot that contribute a few  $\mu\text{A}$  each to  $I_g$ . Moreover, it is also shown in the figure that the sum of the EL integrated intensity from all the seven EL spots matches very closely not only the step increases of  $I_g$ , but also the evolution of  $I_g$  with time between the appearance of two successive EL spots. These results clearly illustrate that the EL intensity of each of the EL spots can be very well correlated to the contribution to  $I_g$  of the defect underlying it, and also that the total value of  $I_g$  is due to the combined contribution of the localised effect of each of these defects.

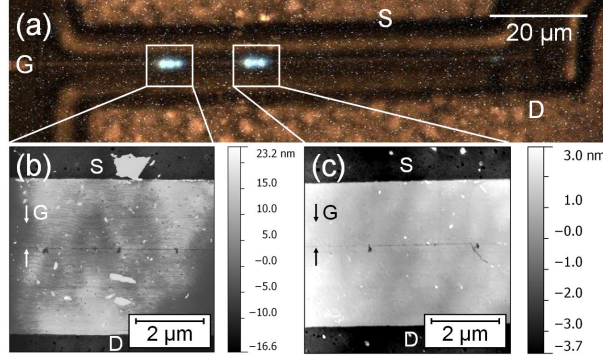
Figure 2. (a) Electroluminescence image of a 100 μm-wide HEMT stressed at  $V_{ds} = 40$  V and  $V_{gs} = -15$  V for 4 minutes. (b) and (c) AFM images of the areas inside the squares of (a) after removal of the passivation and contacts. The top and bottom dark bands in the images are the regions where the source and drain contact edges used to be before removal. The thickness and location of the gate contact before removal is indicated with arrows. The two light grey horizontal lines on both sides of the location of the gate contact in (b) are AFM artefacts.

It is apparent from the above results that each EL spot must be linked to some sort of localised damage on the device that locally contributes to the total leakage current. In order to determine the nature of this damage, the passivation and metallic contacts were removed from the device, so the surface of the semiconductor becomes exposed and is then accessible with an atomic force microscope (AFM). The etching procedure employed for the removal of the metals and passivation was the same as indicated in

Ref. 6: HF:H<sub>2</sub>O (1:10) for the removal of SiN, aqua regia (HCl:HNO<sub>3</sub> 3:1) at 80 °C for 20 minutes, for the removal of the metals, and piranha solution (H<sub>2</sub>SO<sub>4</sub>:H<sub>2</sub>O<sub>2</sub>) at 115 °C for 5 minutes for a final cleansing of the chip surface. The regions of the semiconductor surface where the source and drain contacts used to be before their removal are easily identifiable in the AFM images (see Figure 2), and this aided locating the device fingers after the removal of the contacts. AFM scanning of these regions of the semiconductor surface reveals the presence of a series of small pits that forms an inhomogeneous and discontinuous line along where the drain edge of the gate contact used to be. In addition to this line of defects, larger pits have grown from the gate edge towards the drain at particular spots on the device surface (Figure 2), similar to those reported in Ref. 9. AFM scanning of reference, unstressed devices subjected to the same chemical treatment, did not show any of these surface pits, confirming that they are caused by the off-state stress of the devices. By comparison of the AFM and EL images from all the tested devices, it was apparent that EL hot spots correlate to these larger AFM pits. Moreover, when the AFM and EL images are carefully overlaid, an almost perfect one-to-one correspondence between EL spots and pits in the surface is found (see Figure 2), although such a correspondence becomes more difficult to verify when many EL spots appear together on the EL pictures due to the resolution of the EL capturing system, which implies that two adjacent EL spots have to be separated by at least ~1 μm in order to be well resolved. So, it can be concluded that EL spots do indeed originate at places where the surface defects appear during off-state stress.

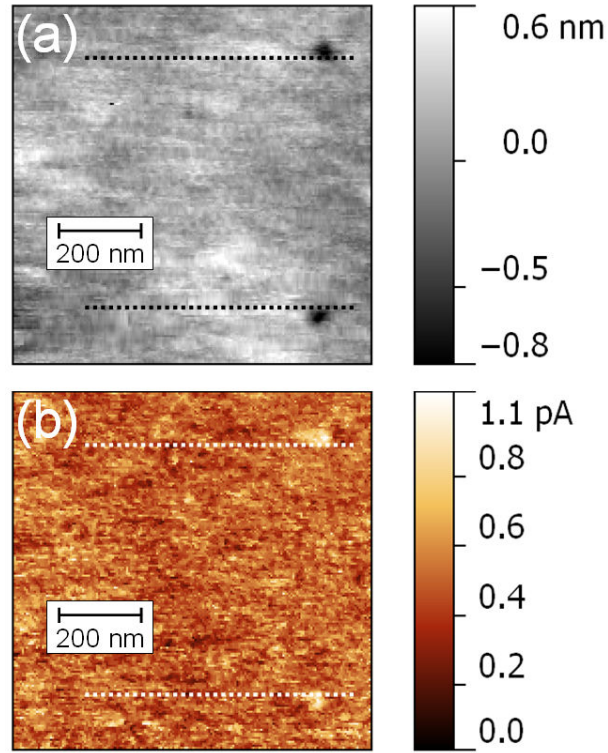
Figure 3. (a) Topography image and (b) current image from two large surface pits. Both images were acquired simultaneously by using a conducting AFM tip at -10 V. Dotted lines indicate the location of the gate contact before removal. This device was stressed at both forward and reverse values of  $V_{ds}$ , and thus shows surface pits on both sides of the gate.

To demonstrate that these large surface pits do indeed provide a leakage pathway in the devices, conducting-tip AFM (c-AFM) imaging of the surface of the semiconductor was employed. Figures 3(a) and (b) show a height map and a current

map obtained from one of these c-AFM scans, respectively. A reverse bias of -10 V was applied to the c-AFM tip to mimic the effect of a reverse bias on the device gate. The electric circuit was closed using focused ion beam-deposited Pt tracks to connect the device mesas to one corner of the chip that is subsequently grounded. Figure 3 shows results from a device that was stressed at forward and reverse  $V_{ds}$  biases, while keeping  $V_{gs} = -15$  V, and thus EL spots, and correspondingly surface pits, appeared at both sides of the gate, confirming these defects are related to the high electric field at the drain-side edge of the gate. From the c-AFM images it is apparent that the current is higher through the pits than through the rest of the semiconductor surface thus confirming the role of the pits as current leakage paths. Therefore, these results directly demonstrate the common origin of EL spots, gate leakage and surface pits.

as possible dislocations or point defect areas. Recalling the results of Figure 1(b), which correlate  $I_g$  and EL intensity, this would imply in turn that the leakage current is not evenly distributed across each of the surface pits. Indeed, c-AFM mapping of Figure 3 indicates the leakage current is higher towards the centre of the pit than towards the edges, consistently with the centre of the pits being deeper and thus closer to the two-dimensional electron gas (2DEG). Nevertheless, it must be noted that the typical pit depth (2 - 3 nm) is much smaller than the AlGaIn barrier thickness of 25 nm. Therefore, in order to connect electrically the surface pit with the 2DEG, a conduction path for the electrons must be present. One possibility would be the presence of groups of trap states that would form a percolation path, consistently with what has been suggested in previous reports<sup>8, 10</sup>. The results shown in this letter would also be consistent with the preferential formation of pits on top of conducting threading dislocations, forming a current leakage path, similarly to that hypothesised in Refs. 13 and 14.

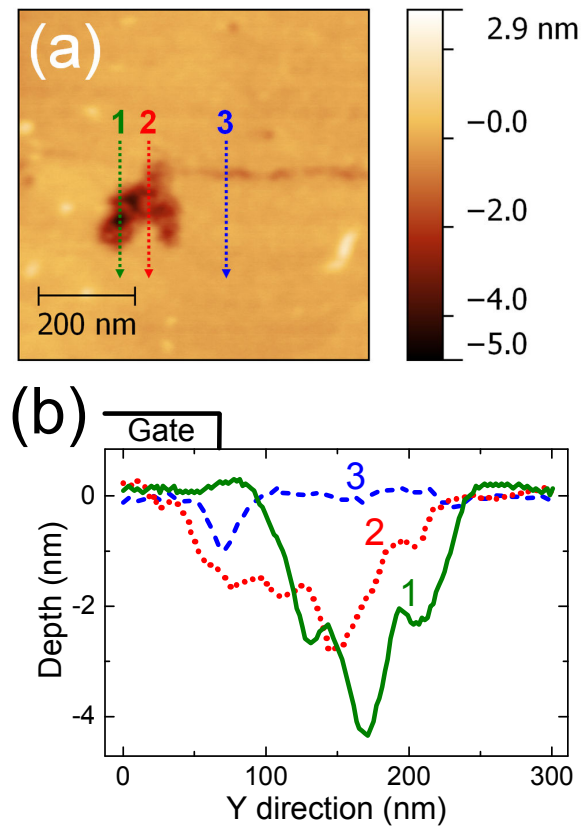
Figure 4. (a) Standard-tip AFM image of one of the surface defects of Figure 2(b).  
(b) Depth profiles of the surface pit of (a) along the indicated arrows.

To study the physical nature of the stress induced large defects that produce the EL spots, detailed standard-tip AFM measurements were performed in order to investigate their morphology. These defects display an internal structure (Figures 4(a) and (b)) that seems to consist of smaller diameter pits which coalesce together as the larger defect structure is formed. This internal structure suggests that the large pits may be generated from the semiconductor surface into the semiconductor device during the off-state stress experiments. Typical sizes of the EL-emitting pits range from 2 to 3 nm in depth and from 30 to 110 nm in their lateral dimension. The EL integrated intensity and pit size were compared for selected pits which are far enough apart from other EL spots to extract a reliable value of the EL integrated intensity from the EL images. No clear correlation between the integrated EL intensity of the EL spots and the area, perimeter or depth of the corresponding pits was found. This suggests that the light emission is not evenly distributed across the whole area of the surface pits. Thus the EL may originate only from selected regions inside the pit such
